This is the published version of a paper presented at *SiF 2018 - The 10th International Conference on Structures in Fire, Belfast, UK*.

FIRE SAFETY CHALLENGES OF TALL WOOD BUILDINGS: LARGE-SCALE CROSS LAMINATED TIMBER COMPARTMENT FIRE TESTS

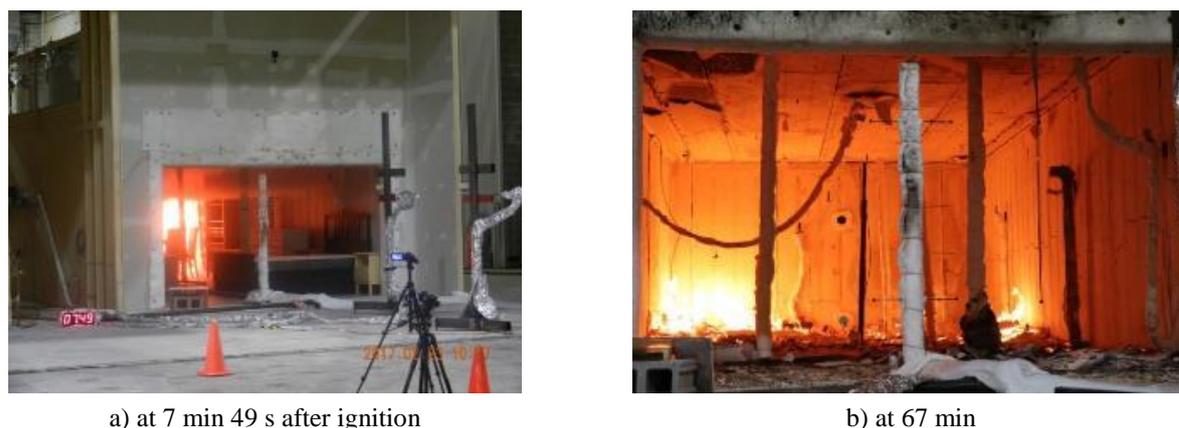
Fig. 3. Photographs of the CLT compartment during Test 1-2 (wide opening)

Fig. 3 shows the typical pre-flashover condition of the compartment and a subsequent view of the compartment when most of the movable fuel has been consumed by the fire. In this example (Test 1-2), all CLT surfaces on the walls and ceiling were protected using two layers of gypsum board and the opening was 3.6 m × 2.0 m (wide opening). Test 1-2 served as a baseline to define the contribution of the movable fire loads and to quantify CLT contribution to the fire in a subsequent test with the same ventilation conditions (Test 1-3).

The test started with the ignition of a sideboard in the room corner and progressed through the dining area. The smoke layer descended to the mid height in the compartment and stayed at this height until flashover. After flashover, an intense burning of room contents lasted for approximately 24 min. The fire started to decay at 37 min and the fire plume ceased to issue from the opening at 40 min. The test lasted for 104 min and was terminated after the heat release rate fell below 500 kW. A hose was used to lightly mist the debris on the floor with water to terminate the test.
