Vertical relative displacements in a medium-rise CLT-building

E. Serrano & B. Enquist

ABSTRACT: Four buildings with clt-panels in their load bearing structure were built at the block Limmnologen in Växjö, Southern Sweden. Their architecture is an example of the new architecture possible with this building system. Properties of these new structures are sought, one of these being their relative vertical displacement over time. These displacements are measured continuously for six storeys, up to now for just over two years. So far, the total measured displacements have reached a maximum of 21.1 mm over the 17.95 meter measuring length. Annual variations of the displacements corresponding to the varying climate may be observed in the data.

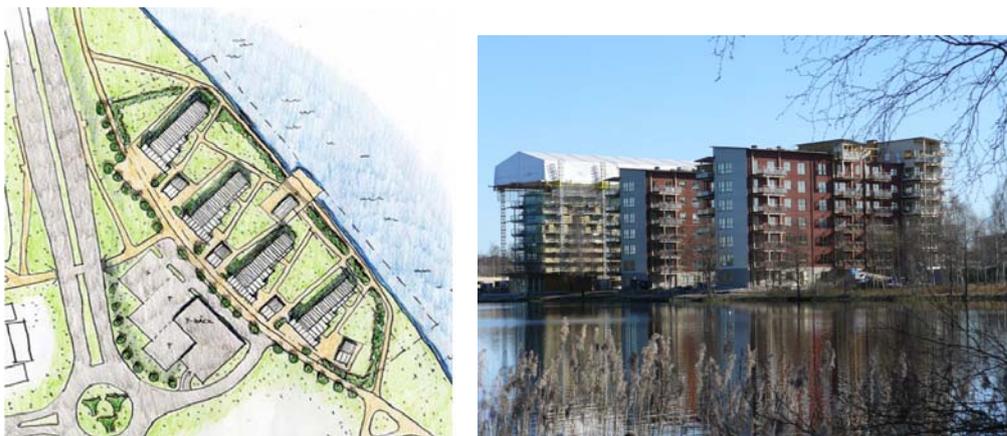
Figure 1. Detailed plan of the building block (a) and photo of the construction site in April 2008 (b).

One of the modern projects in which clt-panels have been used in the majority of the vertically and horizontally oriented load bearing elements is the Limmnologen block in Växjö, southern Sweden. In this block four similar eight-storey residential houses have been built. The de-

tailed plan of the site and the houses, one of them during construction, can be seen in Figure 1. The total number of apartments in the block is 134, 33 or 34 in each house. The builder of this block is Midroc property development, the architect is Arkitektbolaget AB and the structural engineering work has been done by the system deliverers Martinsons AB and in part by Tyréns AB. The Limnologen block is one of the projects in the area Wälle Broar located between city center and University campus in Växjö. Within this area the municipality has set a goal of building around 100,000 m² residential and commercial buildings only using timber in the load-bearing system within 10 to 15 years.

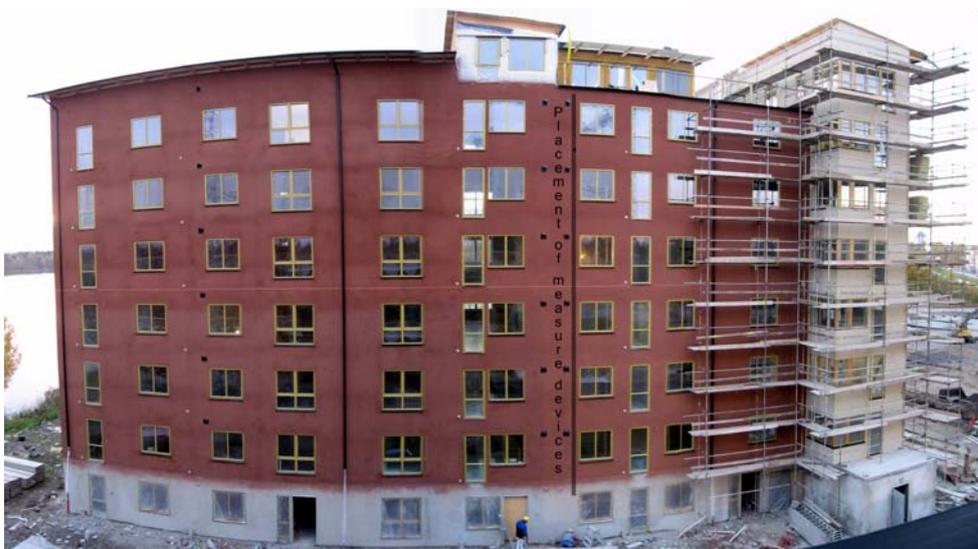
Figure 3. The northern façade of the house where the measuring devices were installed. The devices were installed along the path indicated in the figure. Note that the curved shape of the building is due to the fish eye perspective.

The measuring devices were installed after the house was erected, but before the isolation was completed and before the plaster was attached. They were installed on the northern façade of the second house from north along the path indicated in Figure 3. Note that the curved shape of the building is due to the fish eye perspective.
